Millbrook Proving Ground Ltd.		Millbrook	
Static Stability	Project	VG348-001-01		
Tilt Test	Datapack	MBK16/0229		
	Test Date	26th February 2016		
Issue Date 29th February 2016

## **Test Vehicle Details**

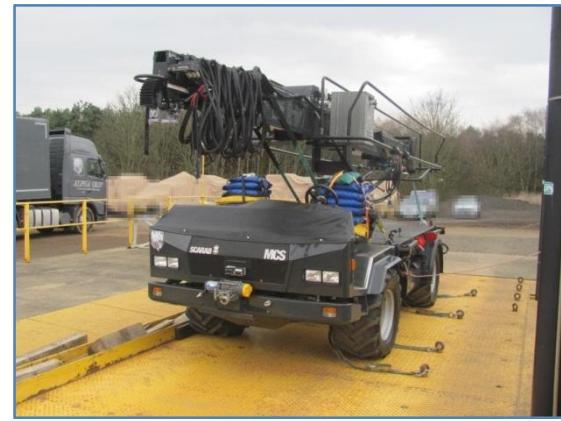
Figure 1 - Test Vehicle

Vehicle Make:	Scarab
Vehicle Model:	MCS 2500
Vehicle Identification No.:	258010357
Total Permissible Mass (kg):	8 040
Permissible Front Axle Load (kg):	4 000
Permissible Rear Axle Load (kg):	5 000
Tyre Make and Model:	Continental Contract AC70G
Tyre Size:	425/55 R17 MPT
Tyre Pressures (psi):	40
Camera Boom Arm:	Alpha Grip SuperTechno 50
Vehicle Test Load:	75 kg Driver, 75 kg Passenger
Vehicle Test Setup:	Neutral, Park Brake OFF

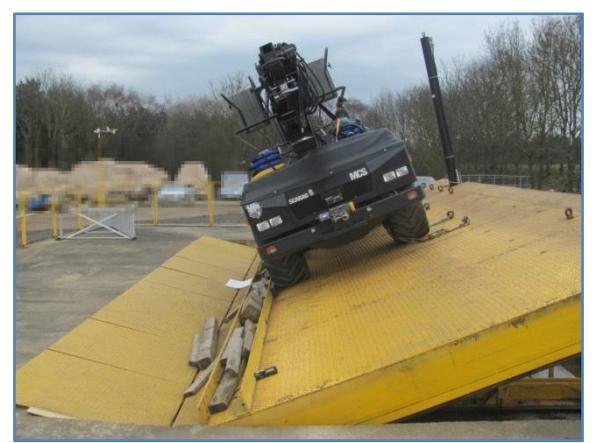
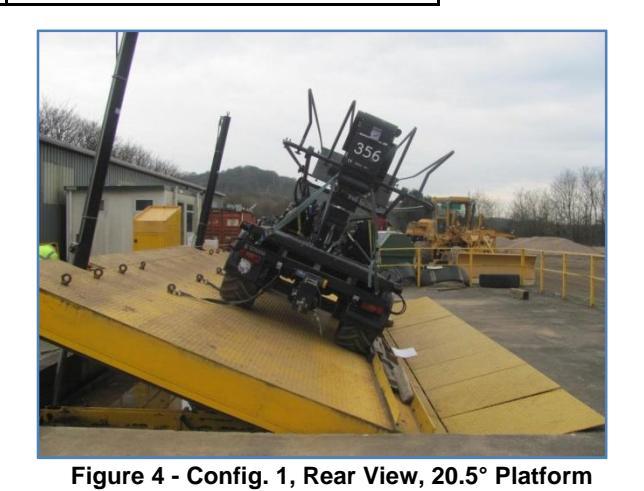
Figure 3 - Config. 1, Front View, 20.5° Platform

Tilt Test Results				
Configu	uration 1	(	Crane column straight vertical	ly.
Connge		28x 16 kg weights located on each side of crane.		e of crane.
	RH Ti	lt Test	Rear Wheel Lift (°)	
	Platform		20.5	
	Body Front		21.1	
	Body Rear		22.5

Tilting the crane column away from the direction of tilt resulted in an increase in rear wheel lift angle of 8.7 degrees with the weights attached to the crane, and by 5.4 degrees without the weights.

Removing the weights attached to the crane resulted in an increase in rear wheel lift angle of 10.2 degrees with the crane column straight, and by 6.2 degrees with the crane column leant over at its maximum away from the direction of tilt.

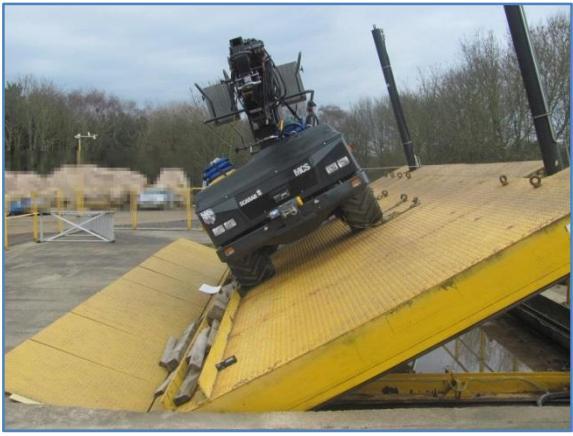
Figure 5 - Config. 2, Front View, 29.2° Platform

Crane column leant away from tilt, at maximum. 28x 16 kg weights located on each side of crane.

RH Tilt Test	Rear Wheel Lift (°)
Platform	29.2
Body Front	29.9
Body Rear	31.7

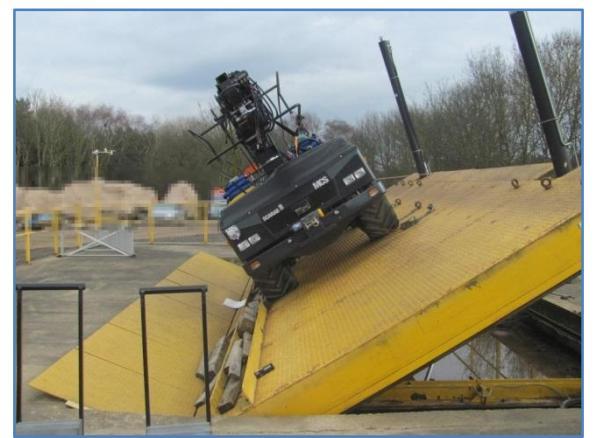
Figure 7 - Config. 3, Front View, 30.7° Platform

Tilt Test Results				
Confiau	Configuration 3 Crane column straight vertically.			
5-		No weights on crane.		
	RH Til	t Test	Rear Wheel Lift (°)	
	Platform		30.7	
	Body Front		31.7	
	Body Rear		32.6

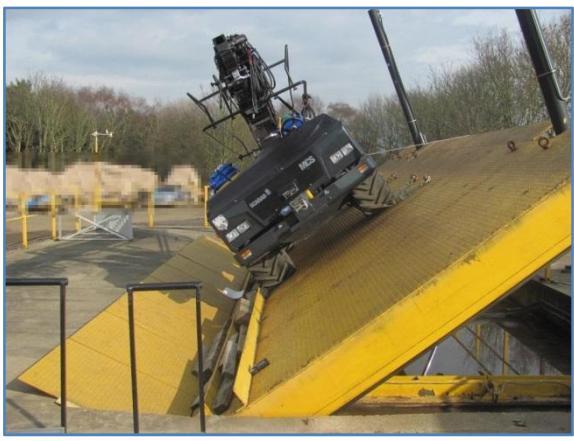
Figure 9 - Config. 4, Front View, 36.1° Platform

Crane column leant away from tilt, at maximum. No weights on crane.

RH Tilt Test	Rear Wheel Lift (°)
Platform	36.1
Body Front	37.1
Body Rear	37.6

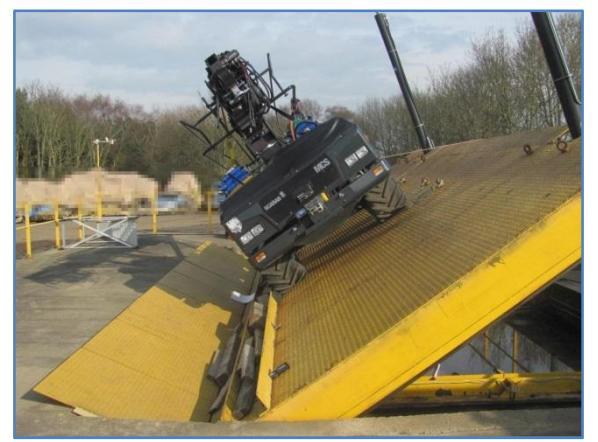
Figure 11 - Config. 5, Front View, 34.7° Platform

Crane column straight vertically. All weights (896 kg) in stowage above rear axle.

RH Tilt Test	Rear Wheel Lift (°)
Platform	34.7
Body Front	35.7
Body Rear	36.5

Moving all weight from the crane into stowage boxes above the rear axle resulting in an increase in rear wheel lift angle of 14.2 degrees with the crane column straight, and by 9.0 degrees with the crane column leant over at its maximum away from the direction of tilt.

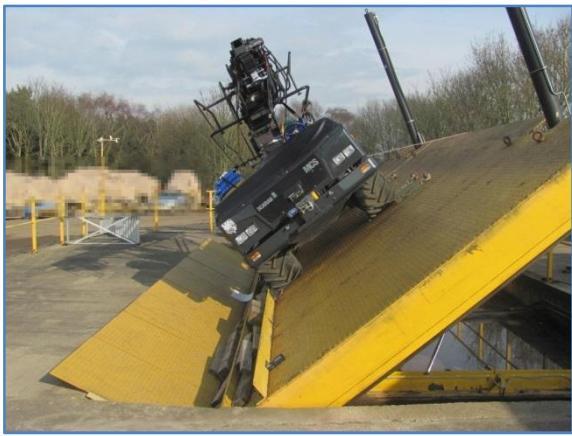
Figure 13 - Config. 6, Front View, 38.2° Platform

Crane column leant away from tilt, at maximum. All weights (896 kg) in stowage above rear axle.

RH Tilt Test	Rear Wheel Lift (°)
Platform	38.2
Body Front	39.1
Body Rear	39.8

An overall increase in rear wheel lift angle of 17.7 degrees was achieved as a result of moving weight from the crane into the rear stowage lockers, and tilting the crane column away from the angle of tilt.
